AIRPORT TRAM RAIL REPAIR

PROJECT DATA Location – Pittsburg, PA

SCOPE OF PROJECT

Repair Concrete Beam that supports Airport Tram Rail

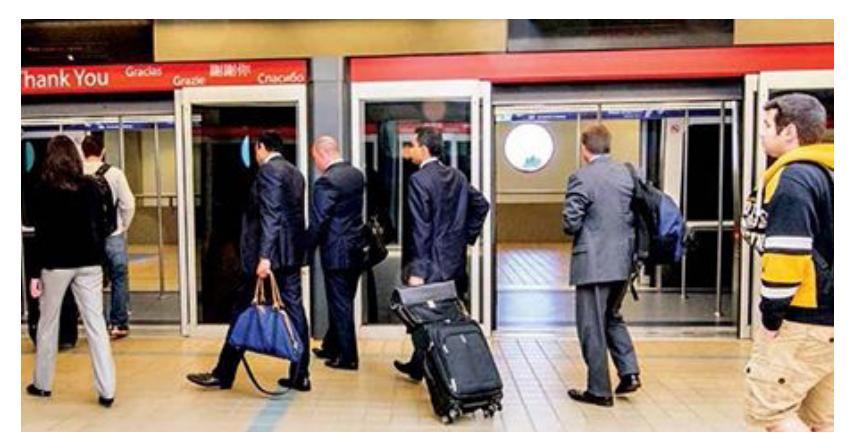
In the Spring of 2018, a concrete beam which supported one of the tracks for Pittsburgh Airport's (PIT) \$14 million people mover system needed to be repaired. The airport authorities were becoming worried about two transverse cracks through the main support beam. The people mover system consists of two driverless, rubber-tired trains that run on two parallel tunnels below airfield taxiways, spanning the half mile between PIT's landside and airside terminals.

The team settled on Euclid Chemicals's DURAL FAST SET LV (Low Viscosity). This high modulus, low viscosity epoxy resin is the perfect solution for general bonding applications and for injecting cracks in concrete and a variety of other substrates.

The project team was able to access the beam at night and completed the repair within a few hours. After some safety testing, the airport was able to reopen the people mover to meet the morning demand. This section of rail has been continuously monitored since the repair was performed over two years ago and no further movement or cracking has developed.
